Mile End Hospital, London

Client: Enfield Council

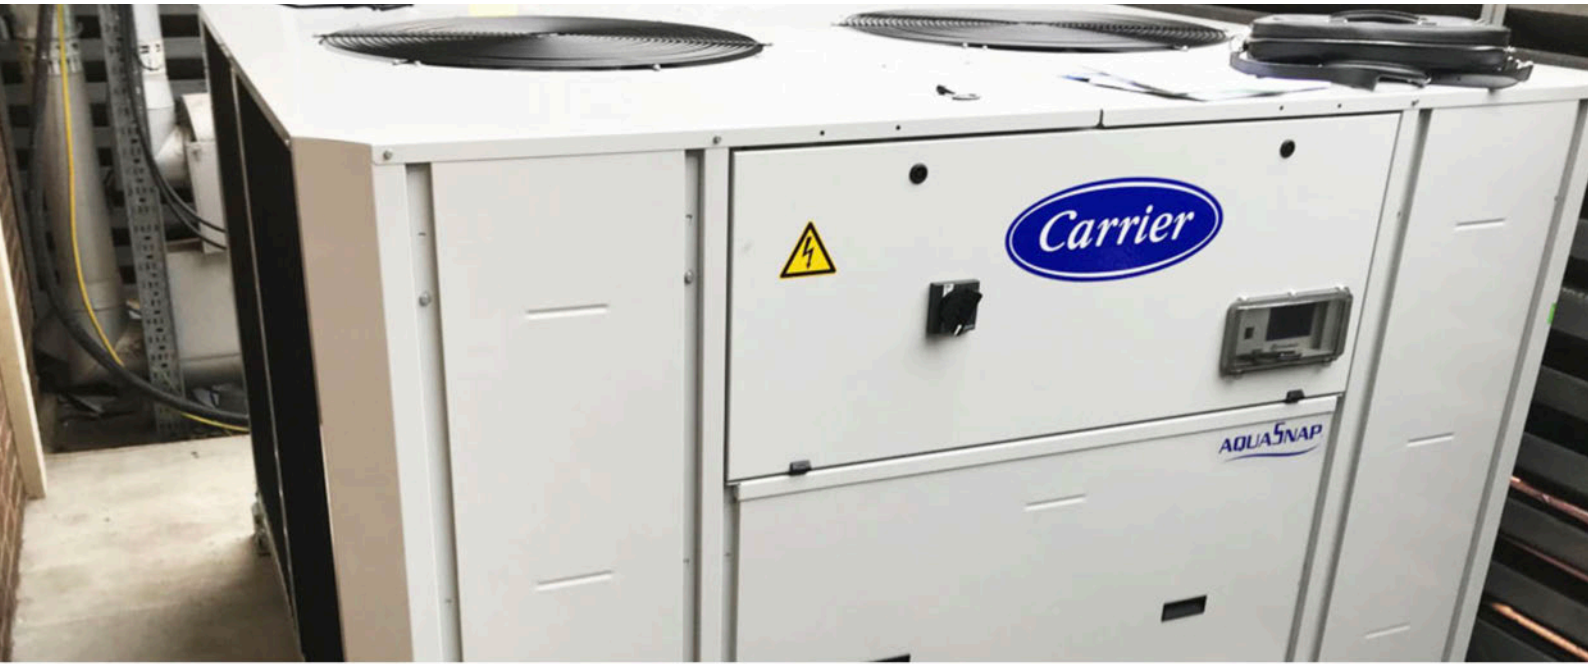
A.C. Preou were asked to replace the air-cooled chiller at the rear of the laundry area. Water samples proved the system had been poorly maintained, which had resulted in corroded pipework, and unit failure.

- Making safe, draining and disconnecting the existing unit from the water and electrical supplies.
- Extend the concrete base to suit the new unit.
- Crane in the new unit, connect pipework and controls
- Clean and red oxide existing pipework
- Dose water treatment, to ensure the longevity of the system.
- Commission unit

The system was back online, ready to keep the hospital cool during the hot summer.
